# FEASIBILITY OF ALTERNATIVES TO THE GOAT ROCK STATE BEACH JETTY FOR MANAGING LAGOON WATER SURFACE ELEVATIONS

Prepared for  
Sonoma County Water Agency

March 10, 2017

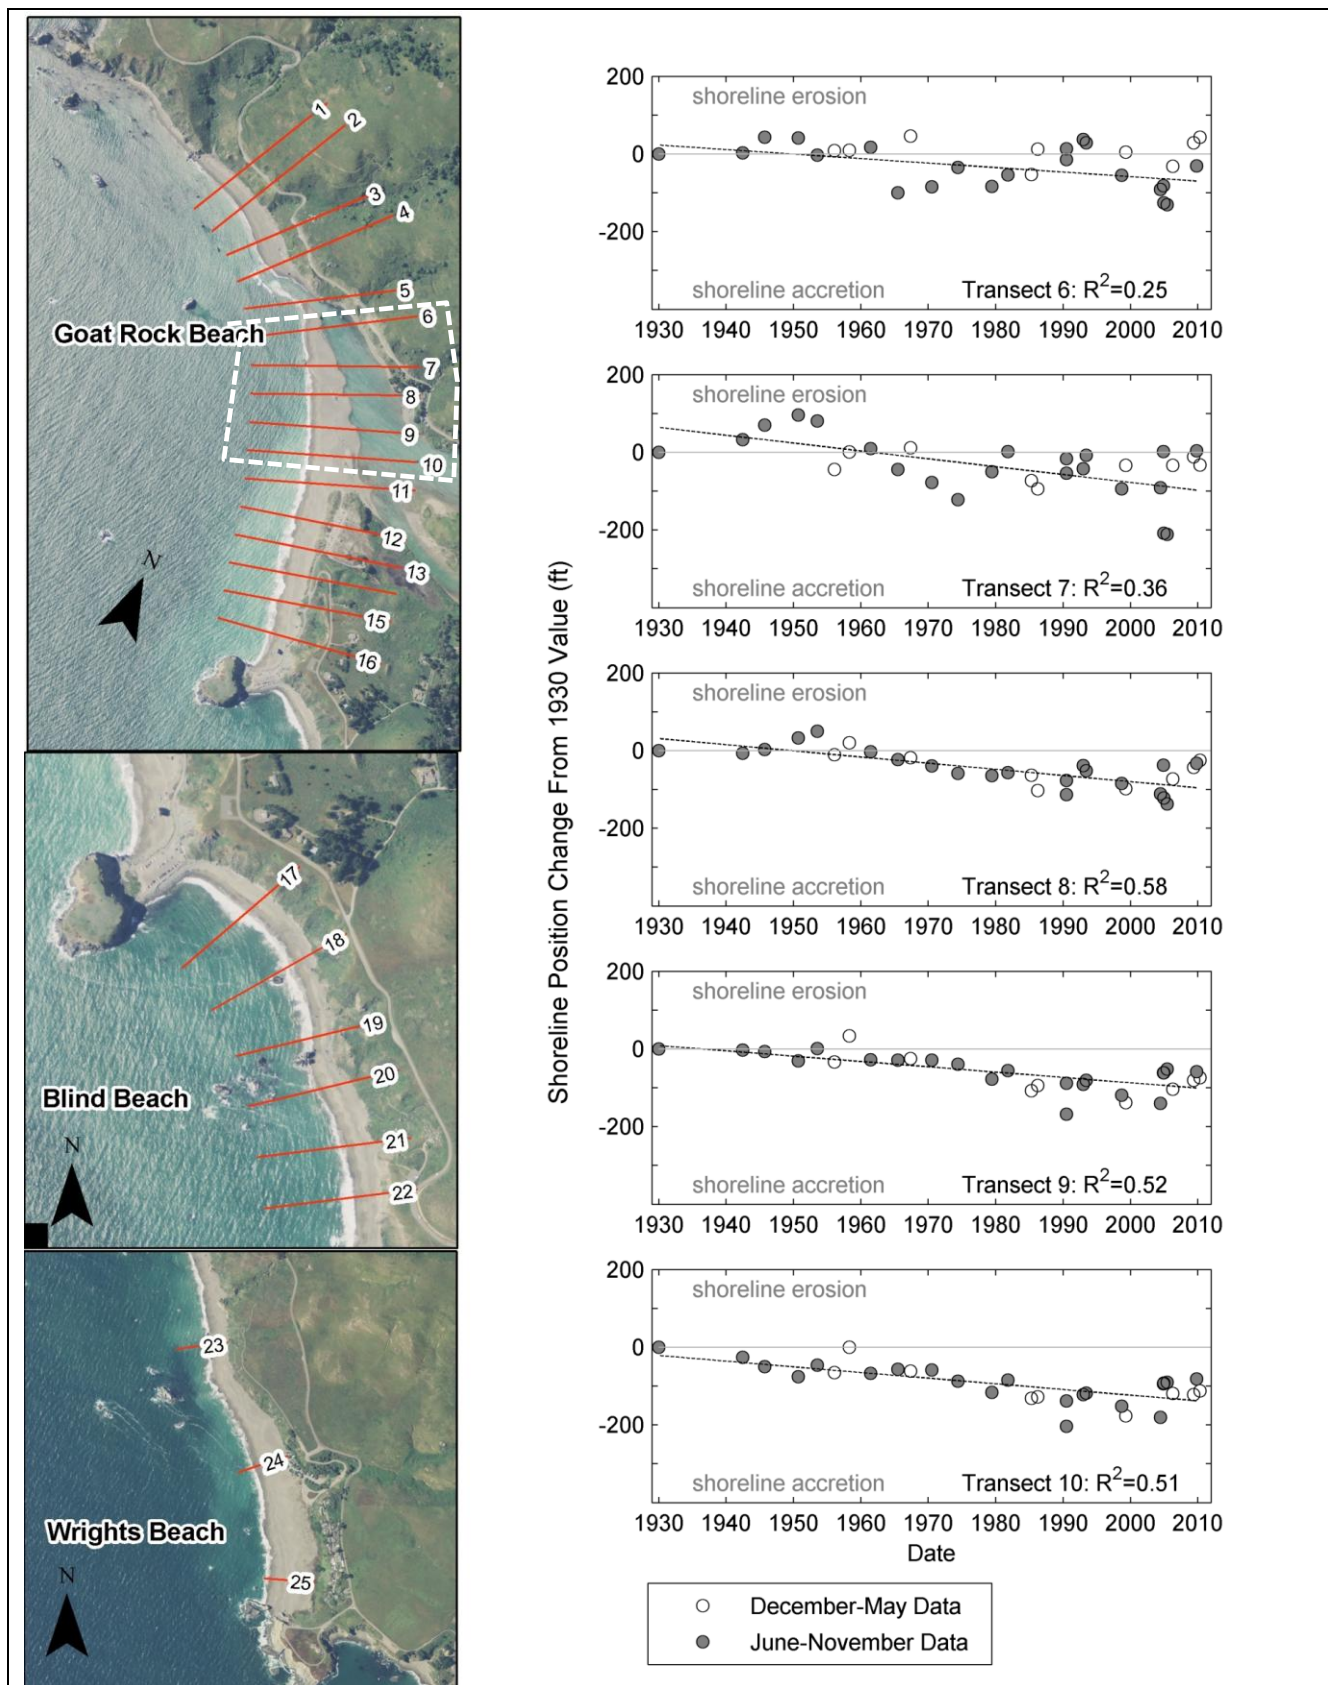
**Figure B-1**  
(left) Index of transects and (right) corresponding shoreline position data for transects 1-5.

NOTE: All linear trends were obtained using summer-fall data.

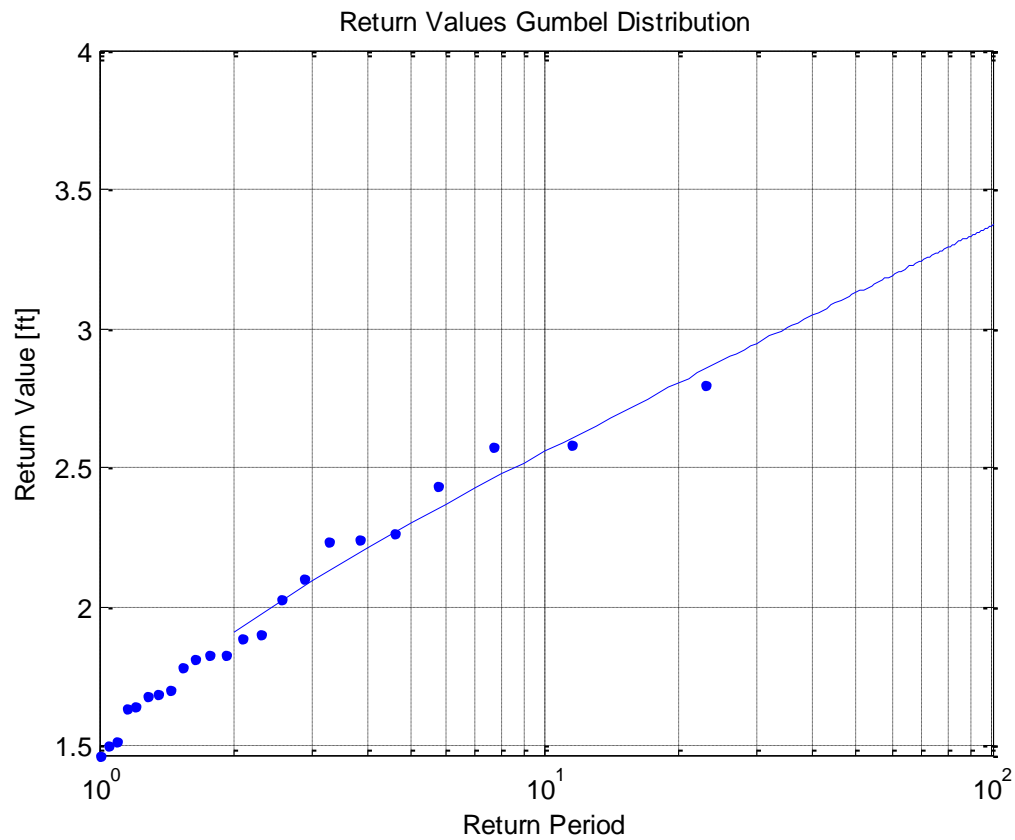
**Figure C-1**  
Predicted wind-wave heights and return periods (years).

NOTE: Wind-wave heights estimated after Resio et al. (2006) using wind data from the Bodega Marine Laboratory.

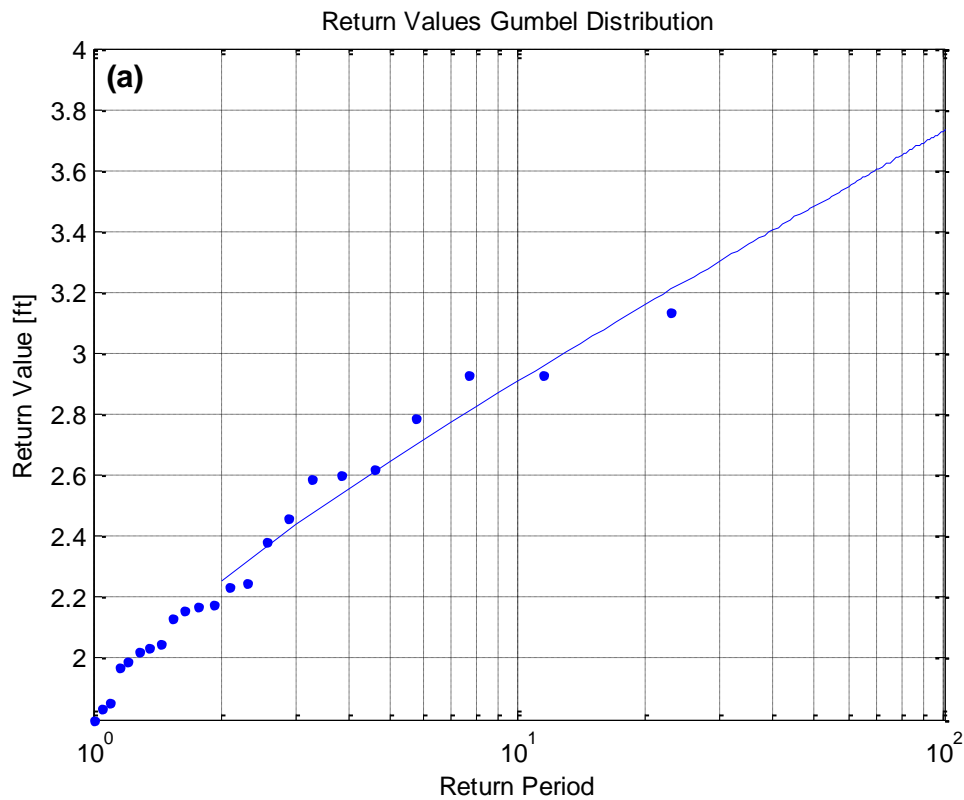
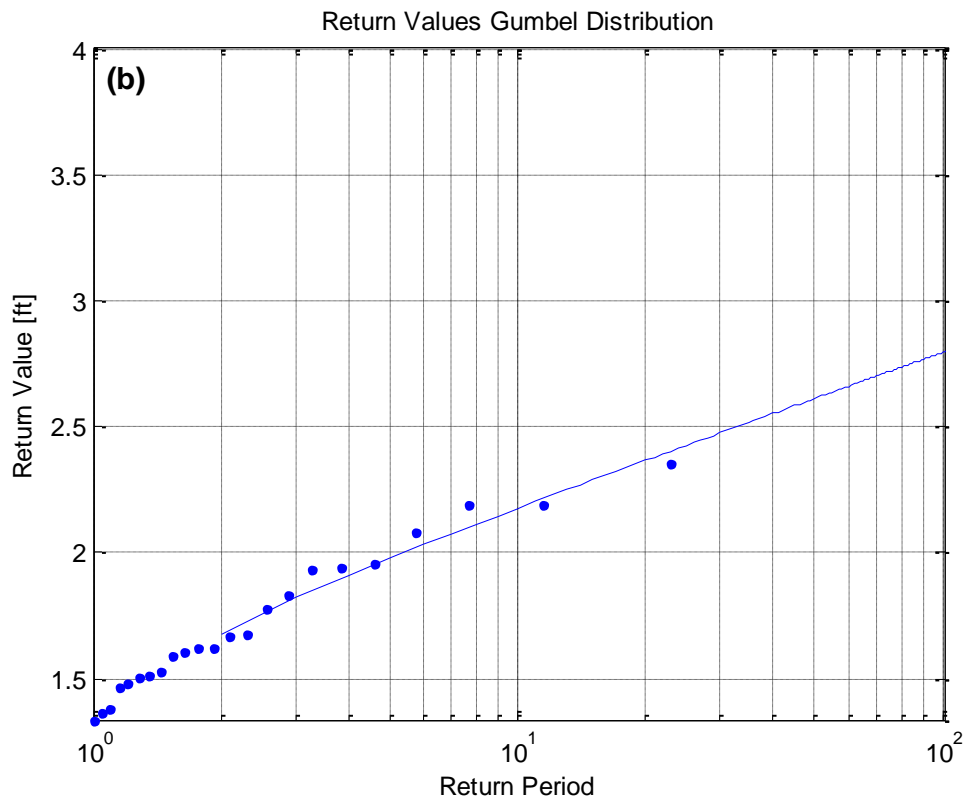
**Figure C-2**  
Predicted wind-wave runoff and return periods (years) for estuary shoreline slope of (a) 1:2 and (b) 1:3.

NOTE: Wind-wave runoff calculated using wind-wave heights estimated after Resio et al. (2006) using wind data from the Bodega Marine Laboratory.

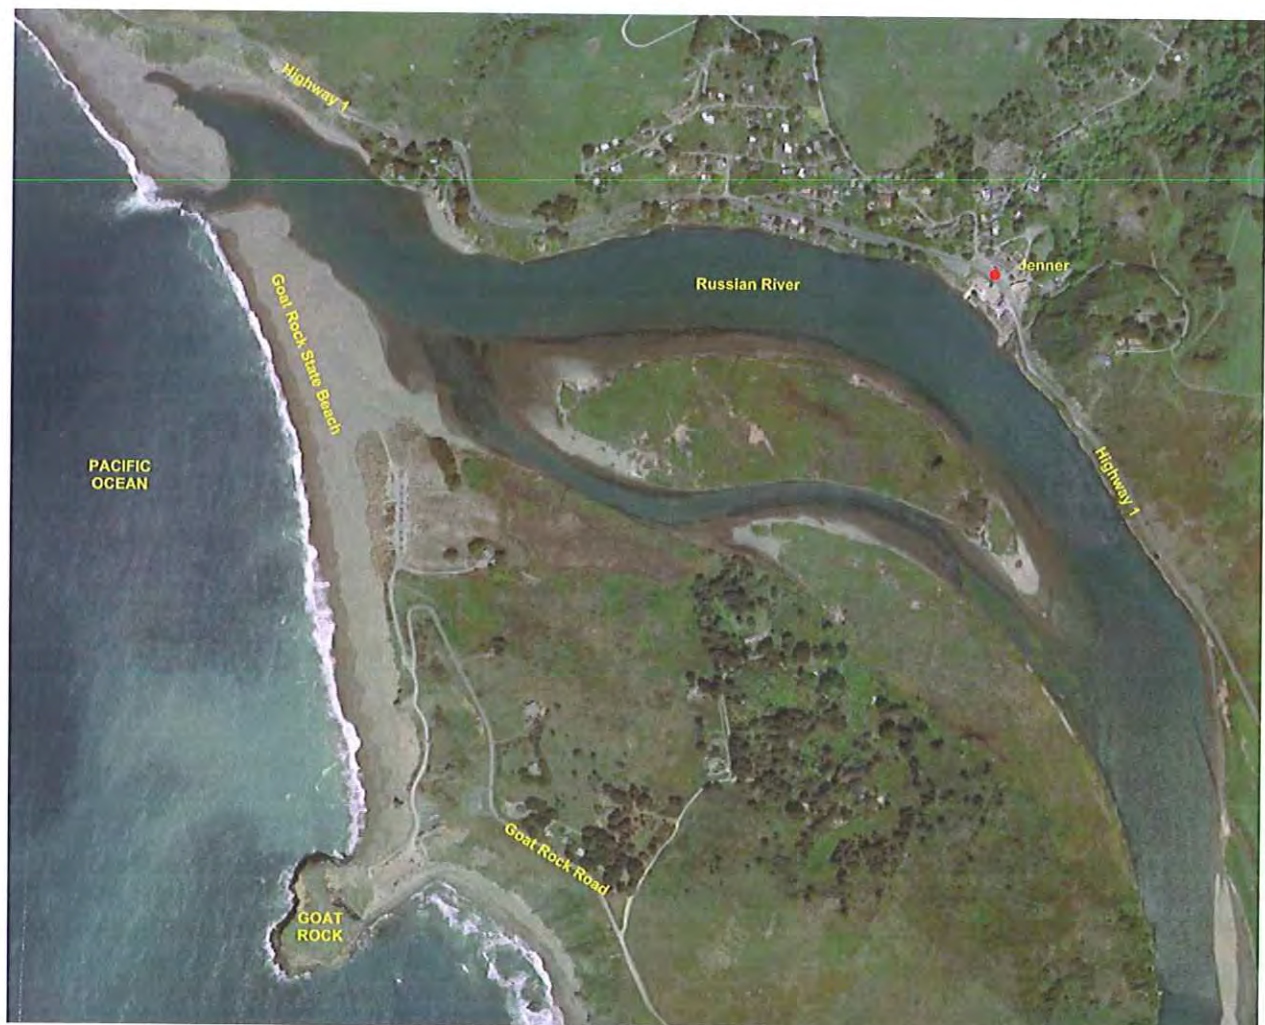
**Figure 1:** Goat Rock State Beach and vicinity.

The crescent shaped beach extends from Goat Rock on the south to the base of the cliffs bordering Highway 1 on the north, as shown in Figure 1. Goat Rock (photo at left) is an iconic outcrop of the Sonoma Coast. The rock is barely attached to the mainland by a narrow isthmus that was created by previous quarrying operations. The northernmost 730 meters (m) of

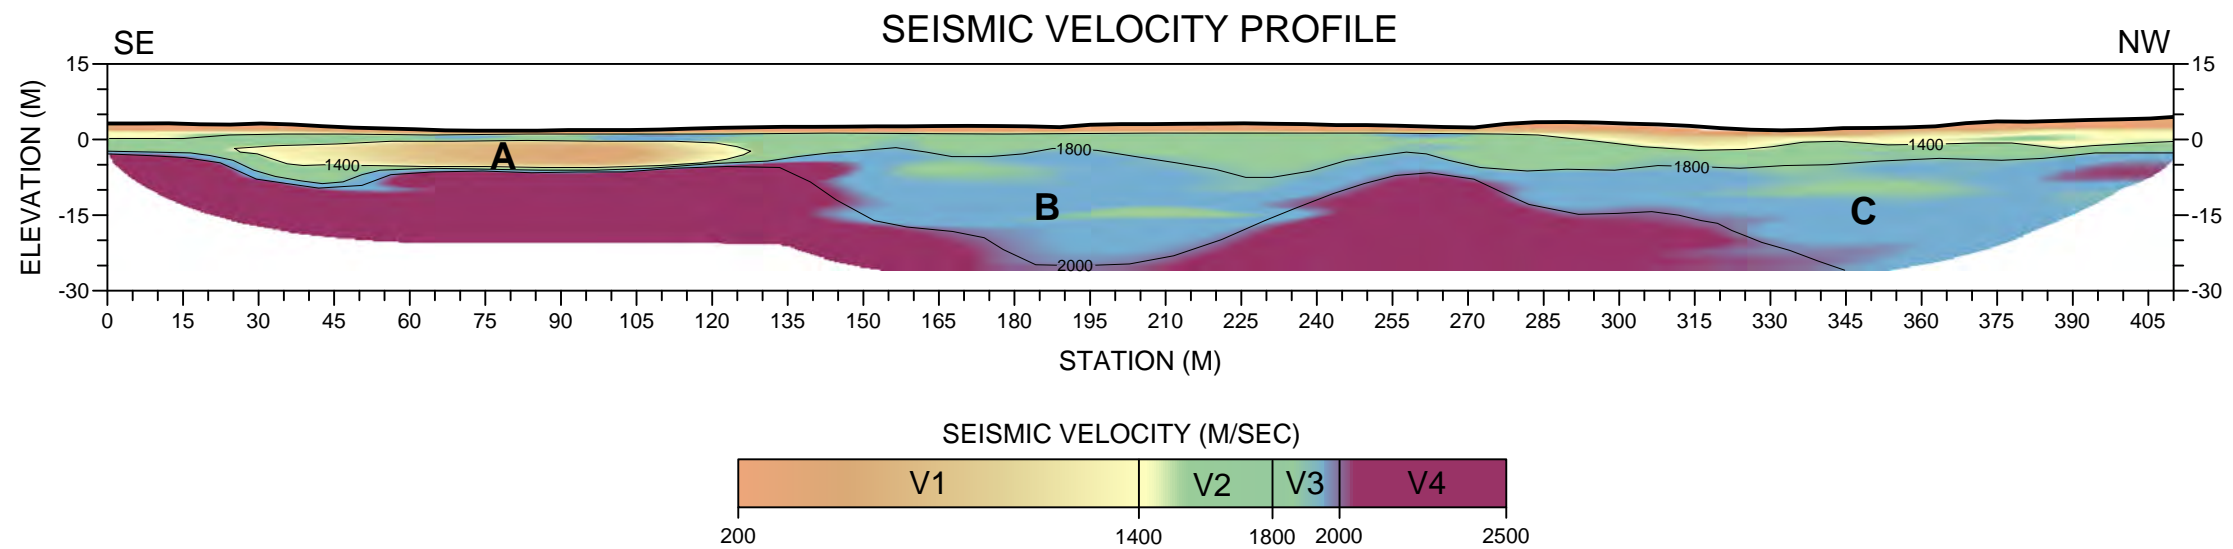
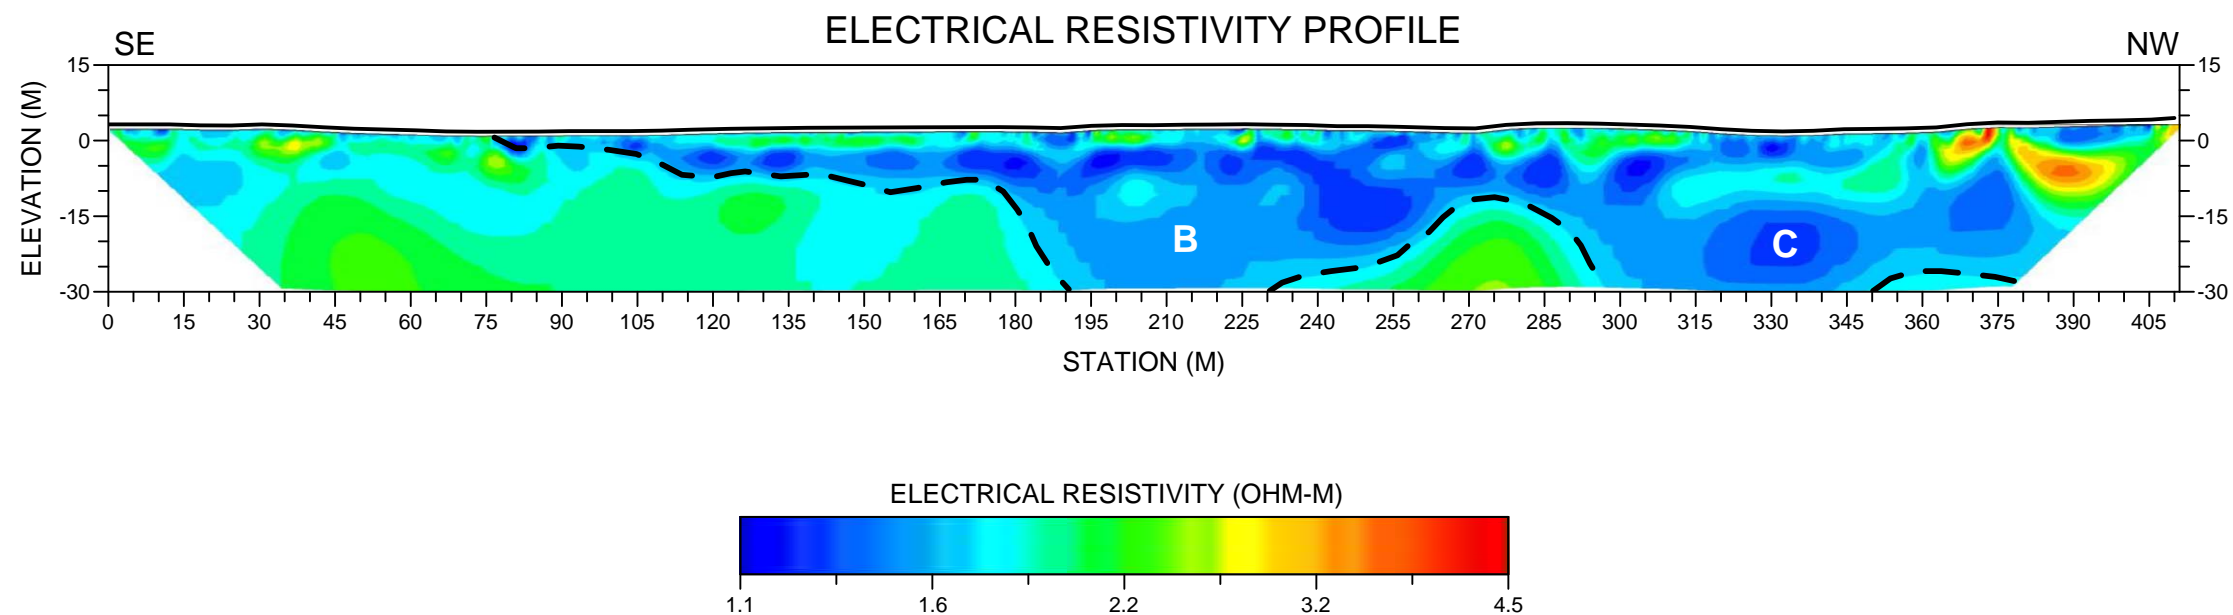
INTERPRETATION	
— — —	INTERPRETED BEDROCK SURFACE
<b>A,B,C</b>	BURIED RIVER CHANNEL

<b>NORCAL</b>	<b>SEISMIC VELOCITY AND ELECTRICAL RESISTIVITY PROFILES GEOPHYSICAL INVESTIGATION GOAT ROCK STATE BEACH</b>			
	LOCATION: JENNER, CALIFORNIA			
	CLIENT: SONOMA COUNTY WATER AGENCY		<b>PLATE 2</b>	
	JOB #: 14-165.12	NORCAL GEOPHYSICAL CONSULTANTS INC.		
	DATE: APR. 2015	DRAWN BY: G.RANDALL		APPROVED BY: WEB

Most of the electrical resistivity (ER) profile shown on Plate 2 is dominated by electrical resistivity values in the lower half of the range, below 2.5 ohm-m (blue to green contours). The only place where higher values occur (yellow to red contours) is in the near surface which probably consists primarily of dry to moist sand. In spite of the low range of resistivity values, it appears that the ER profile does exhibit some interesting geologic features. Most notable is the interface between the dark blue contours (<2 ohm-m) and the underlying light blue to green contours (2.0 to 2.5 ohm-m). The configuration of this interface, which we've denoted by a dashed line, is similar to that of the 2,000-m/sec contour described in Section 4.1. Although the two are not exactly the same, they are close enough that we interpret them both as an approximate representation of the bedrock surface. That being the case, the material underlying the interface represents bedrock and the material overlying the interface represents unconsolidated materials consisting of sand, river sediments and possible terrace deposits. The fact that ER of these materials are so low suggests that the materials are saturated by relatively saline water. This implies that sea water intrusion is occurring within the zone defined by the light blue to dark blue contours. If this is the case, the highest flow rates probably coincide with the darkest blue shading.

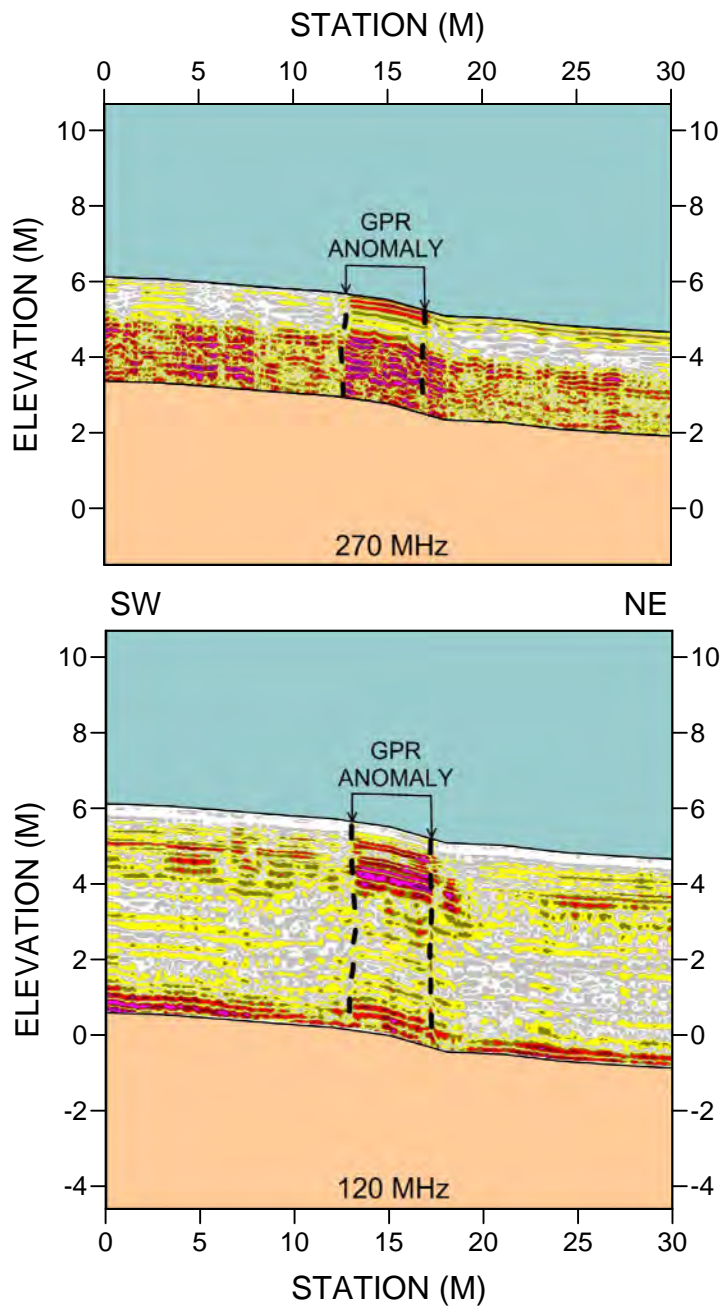
PLATE  
**C1**

--- Interpreted Limits of GPR Anomaly

Note: Vertical Exaggeration = 2:1

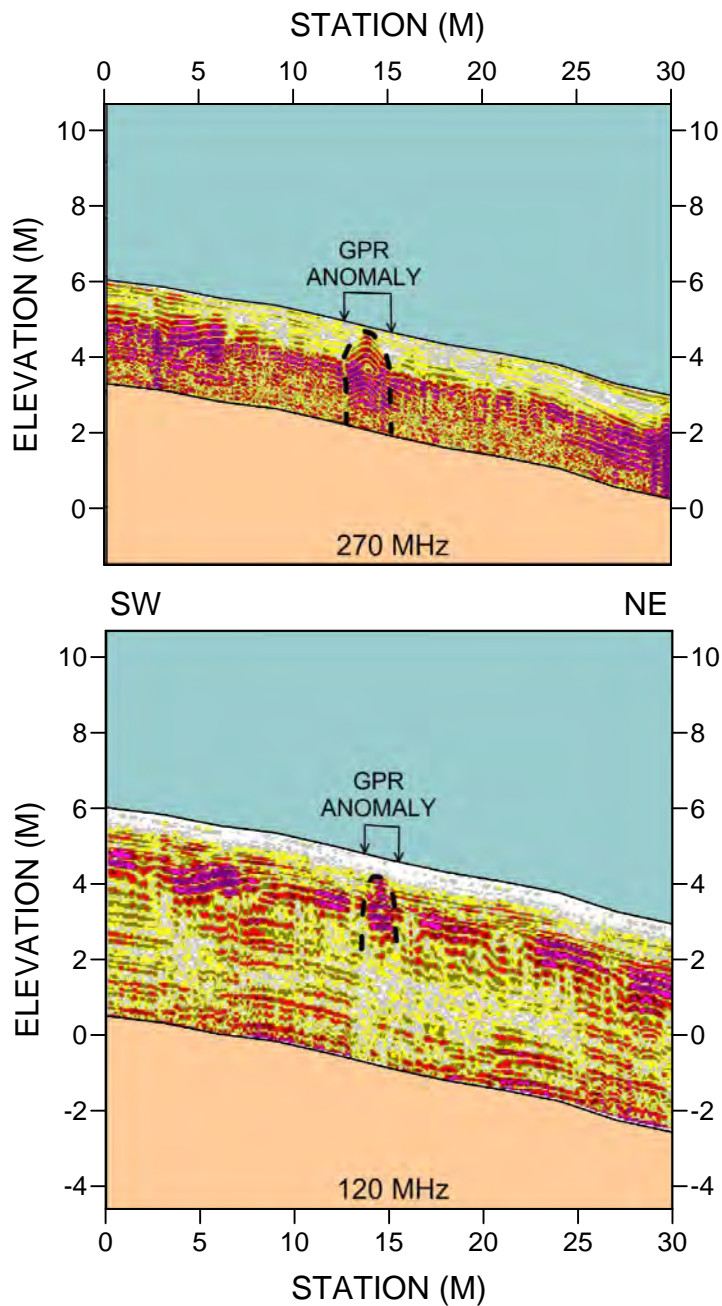
PLATE  
**C2**

--- Interpreted Limits of GPR Anomaly

Note: Vertical Exaggeration = 2:1

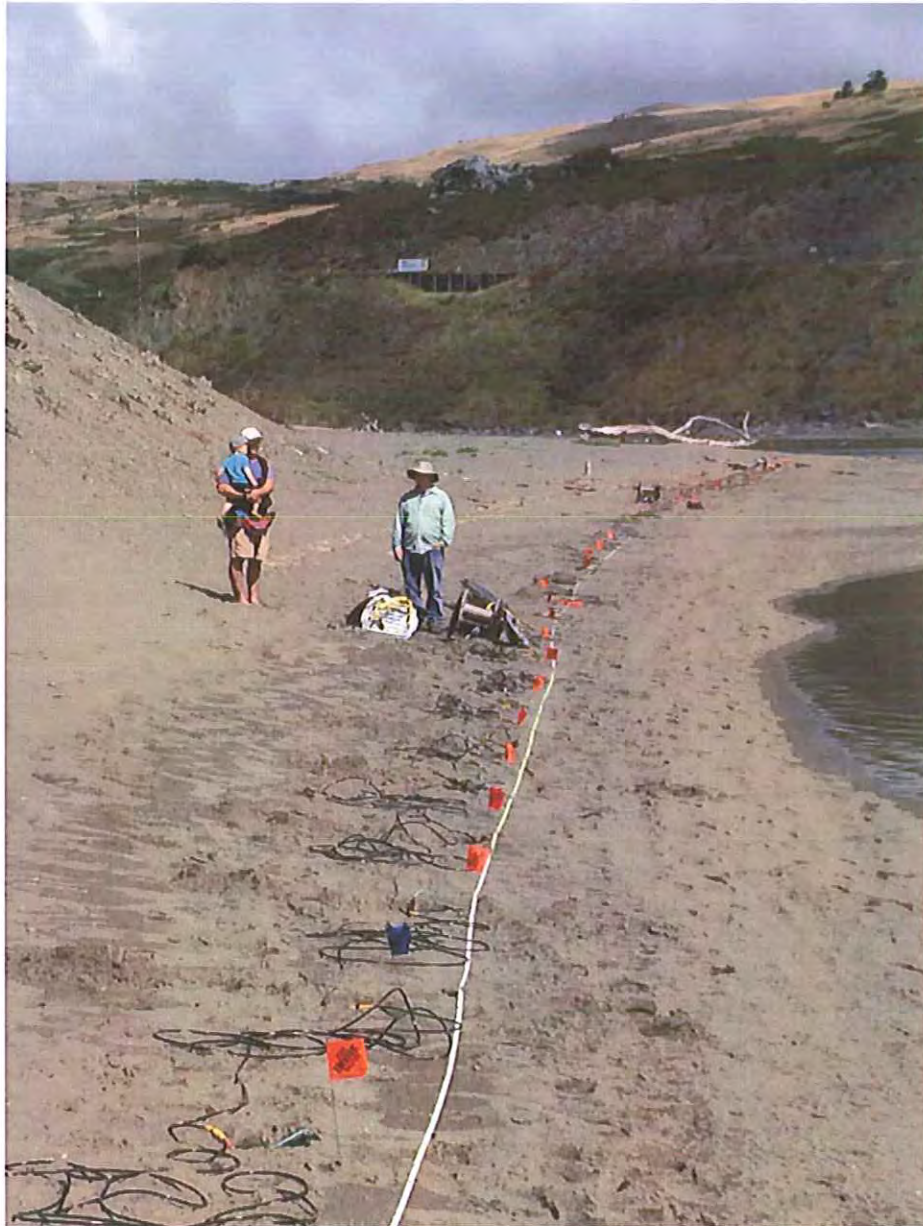
**Figure 1:** Looking northwest along a portion of SR-1. Pin flags mark the geophone locations which, in most cases are buried at depths of 15- to 30-cm.

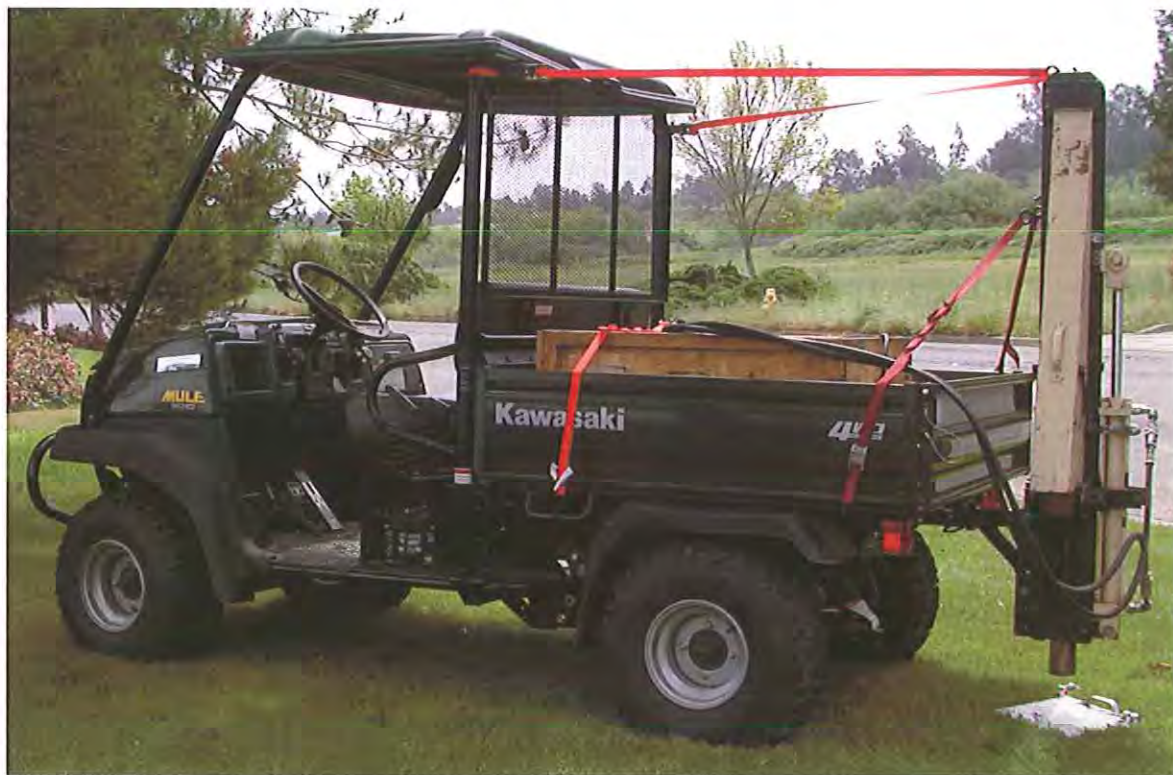
**Figure 2:** Digipulse AWD-100 mounted on Kawasaki Mule 4 w.d. ATV.

Seismic energy was produced at each shot point by multiple impacts with a Digipulse AWD-100 accelerated weight drop against an aluminum strike plate placed on the ground surface. The AWD-100 consists of a 1-m long cylindrical weight that is lifted to a height of about 36-cm by a hydraulic ram. The weight is lifted against the restraining force of a pre-tensioned industrial elastic band. When the weight reaches its maximum height it slips off the ram and accelerates downward until impacting the strike plate. The AWD-100 was mounted on the back of a Kawasaki Mule 4 w.d. all-terrain vehicle, as shown in Figure 2.

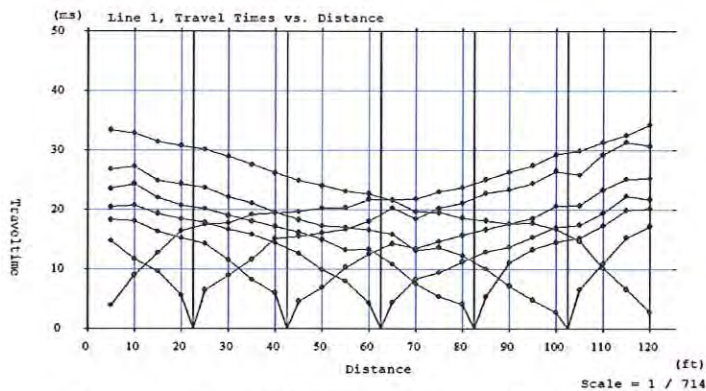
Figure 3: Example SR Time-Distance Graph

Preliminary seismic refraction models were computed using the software package *SeisImager* which was written by Oyo Corporation (Japan) and distributed by Geometrics Inc. The first stage of seismic processing included compilation and identification of first arriving P-wave energy at each geophone from each shot point. This process was conducted using *Pickwin, Version 3.2.0.1* (2004), which is part of the *SeisImager* package. A second interactive program *Plotrefa, Version 2.8.0.1* (2006) was used to assign surface elevations to each geophone and velocity layer assignments to travel time. We then used *SeisImager's* time-term routine to compute a 2D seismic velocity model based on these inputs. Actual examples from this survey are presented in the following figures.

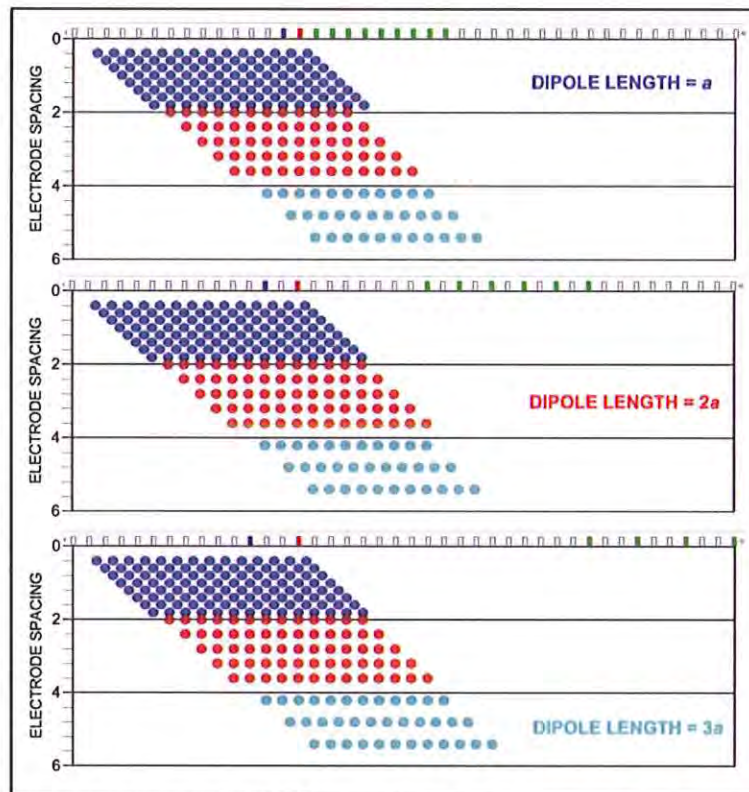
**Figure 2:** Dipole-dipole diagrams for dipole lengths of 1, 2, and 3 times the electrode separation ( $a$ ).

Moving the array along a line and measuring  $\rho_a$  at even intervals (multiples of  $a$ ) results in a data set that can be used to construct a cross-section (profile) depicting variations in electrical resistivity versus depth and distance. The depth of investigation of the profile can be increased by increasing both  $a$  and  $n$  by even multiples of  $a$ .

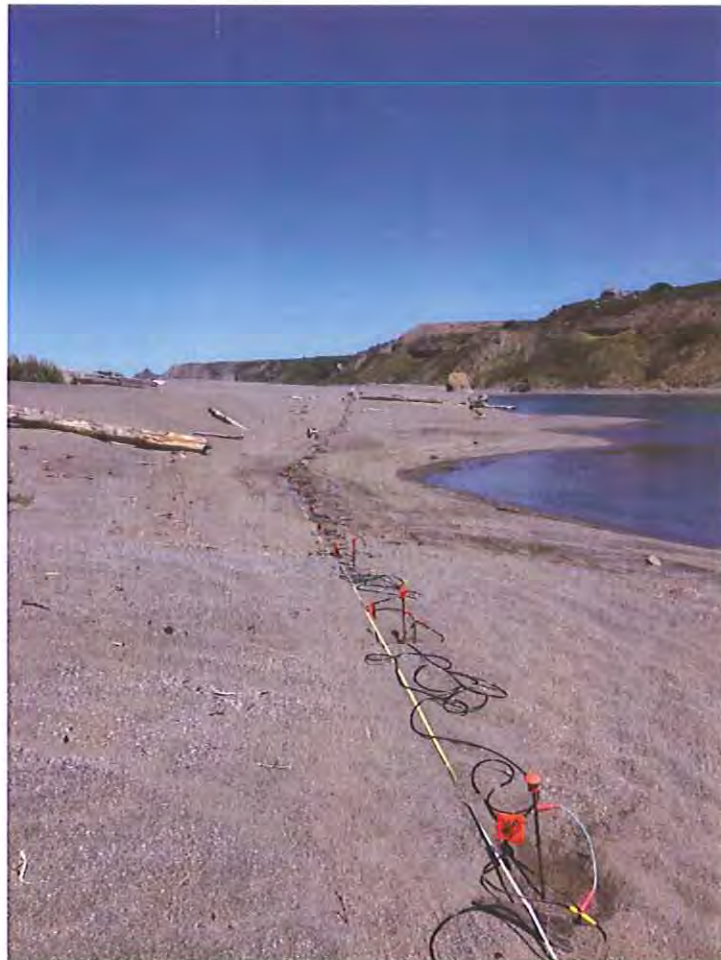
**Figure 3:** A portion of the electrode array looking northwest. Note rebar in foreground.

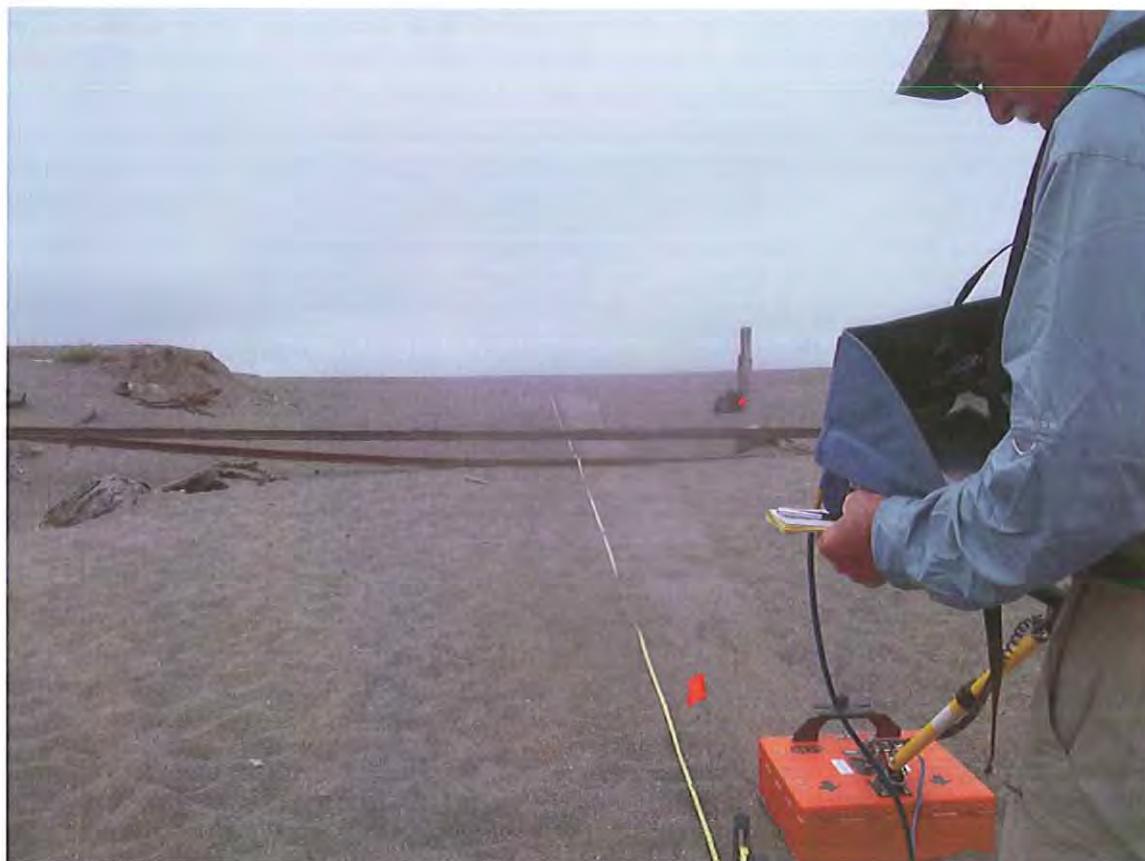
**Figure 1:** Deployment of 270 MHz transducer (orange box in foreground). Note path of transducer in background. Also shown is a portion of the abandoned railroad tracks that were used to transport quarry materials from Goat Rock during construction of the jetty.

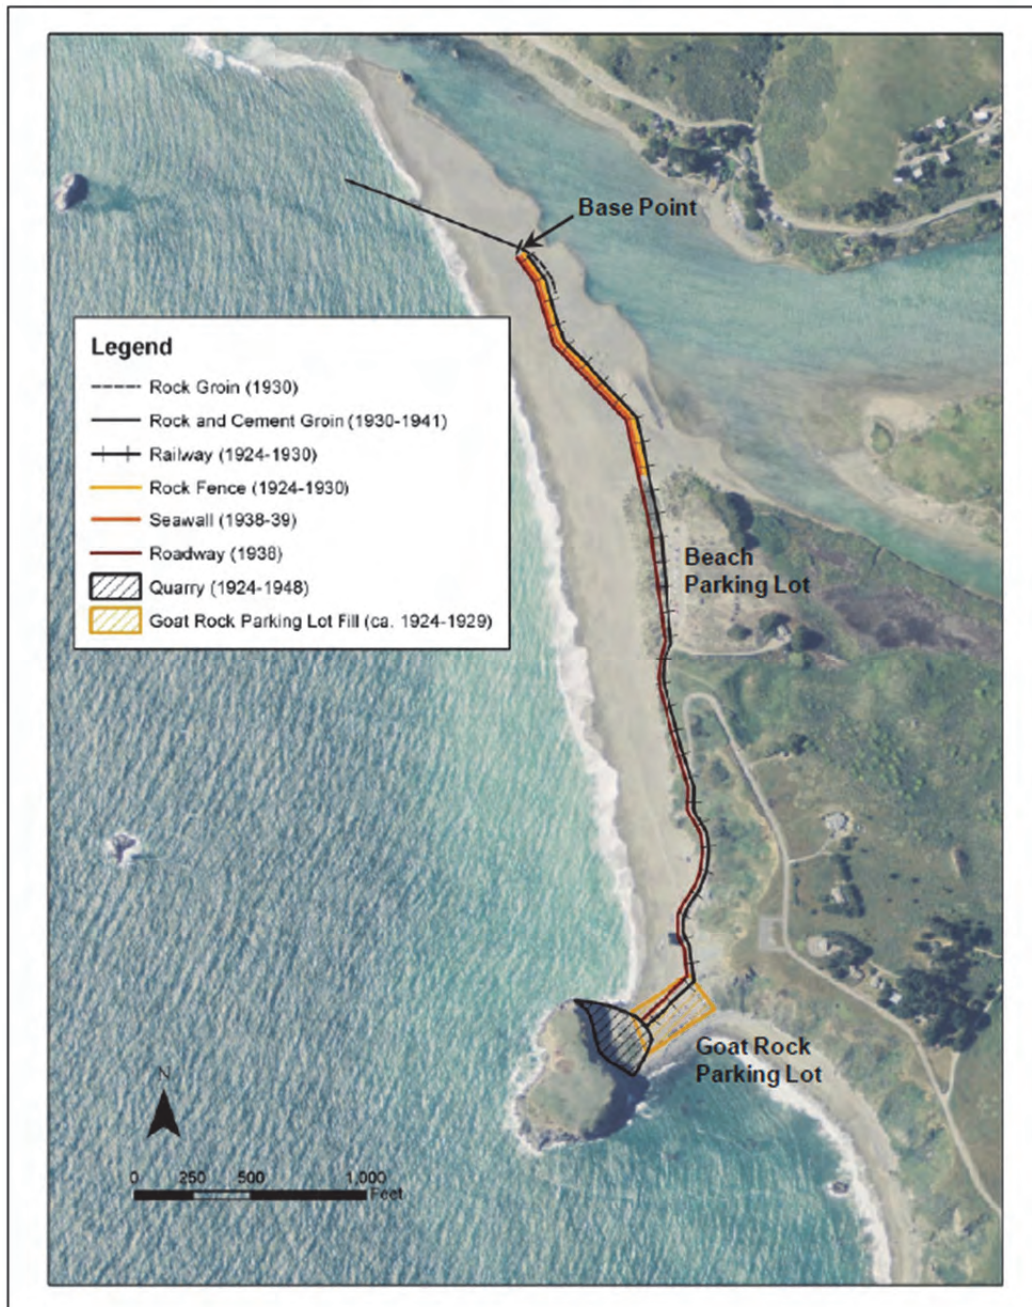
Figure 1. Plan view of jetty complex elements constructed between 1930 and 1941, courtesy of ESA PWA.

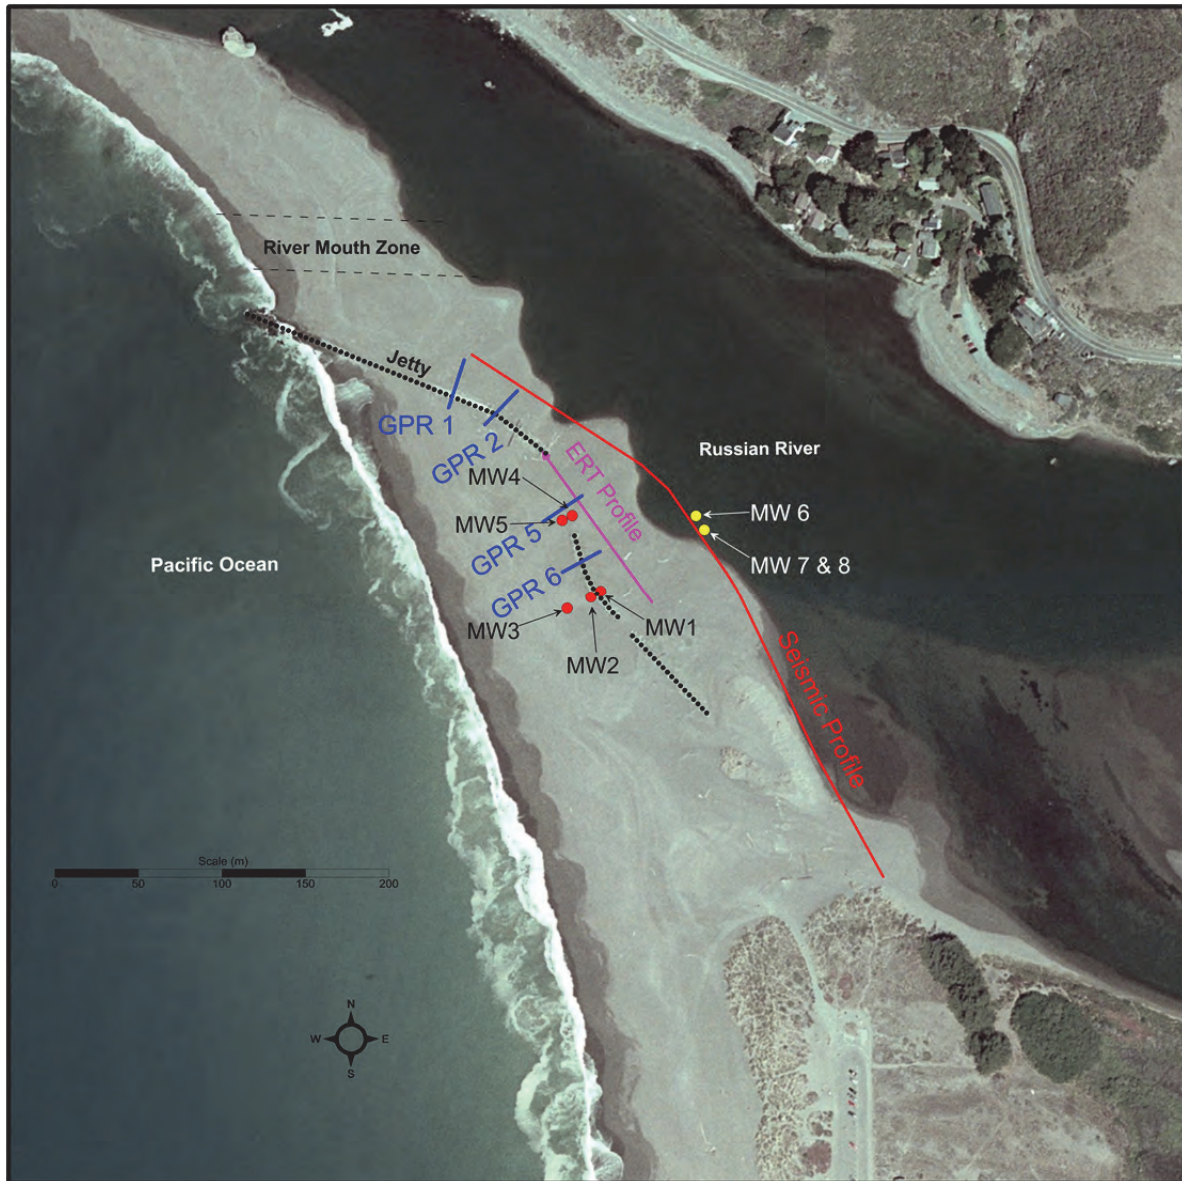
Figure 2. Plan view map of GRSB showing the locations of the Jetty components, ERT profile (magenta), seismic profile (red), and GPR profiles (blue). Deep (12 m) monitoring wells shown as red dots and shallow (2 m) shown as yellow dots.

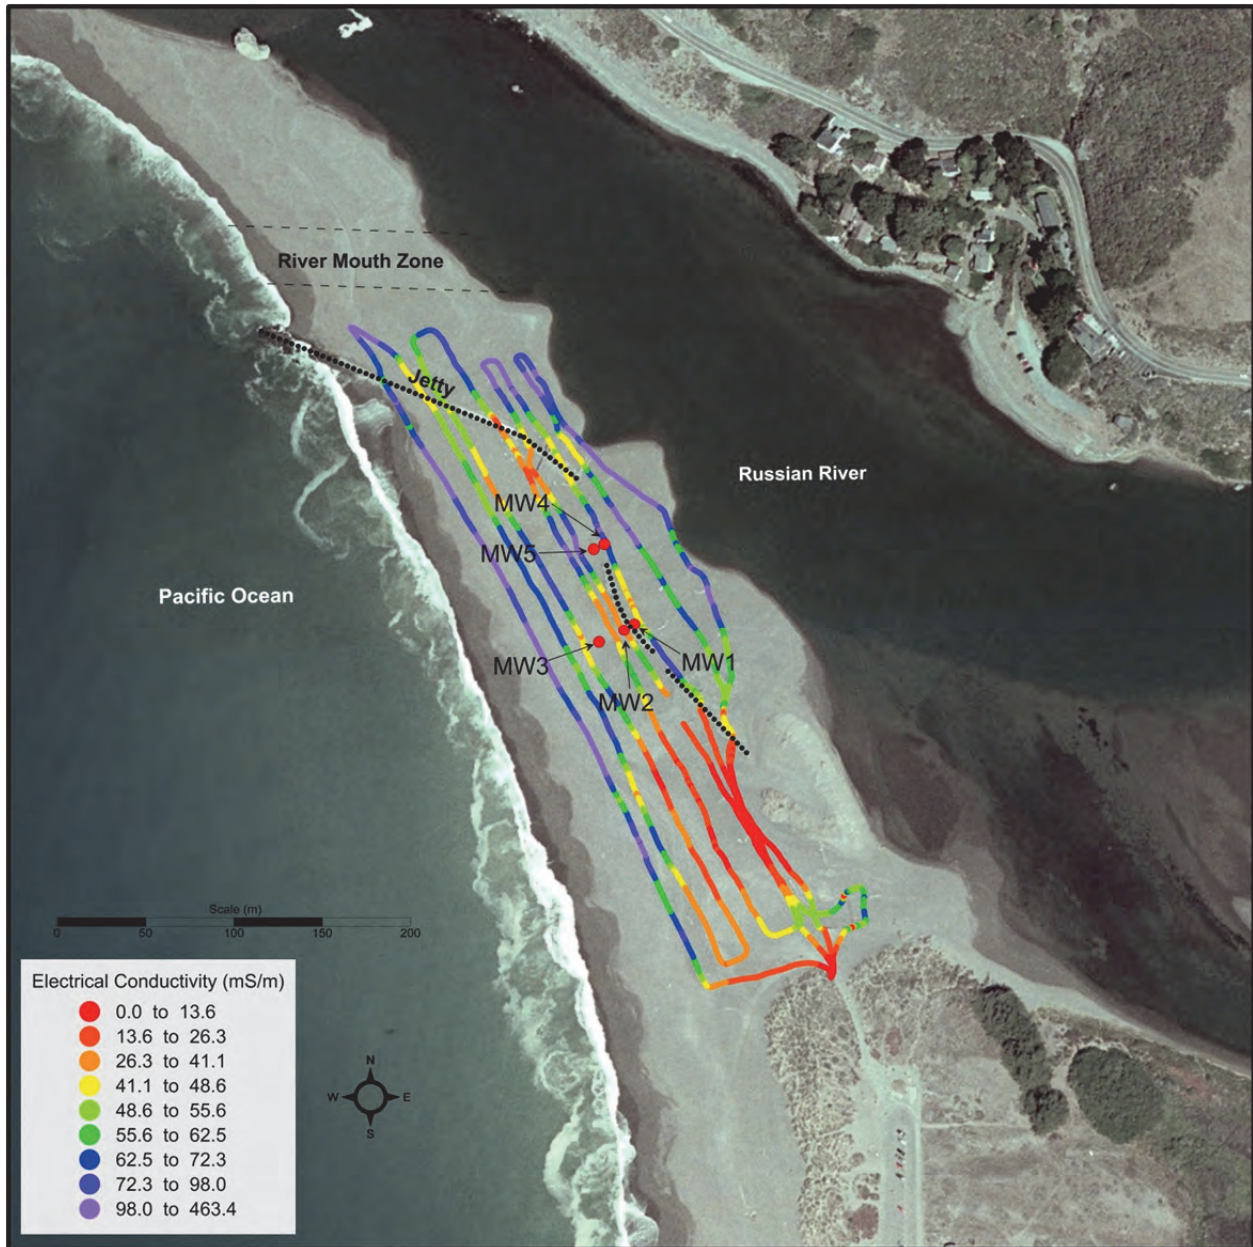
Figure 3. Plan view map showing the Jetty components, open river mouth zone, and electrical conductivity results from March 4<sup>th</sup>, 2014 survey. Lower salinity/drier soils are represented by red to yellow colors and higher salinity/wetter soils by green to purple colors. Monitoring wells (red dots labeled by 'MW') installation locations were decided from the electrical conductivity results.

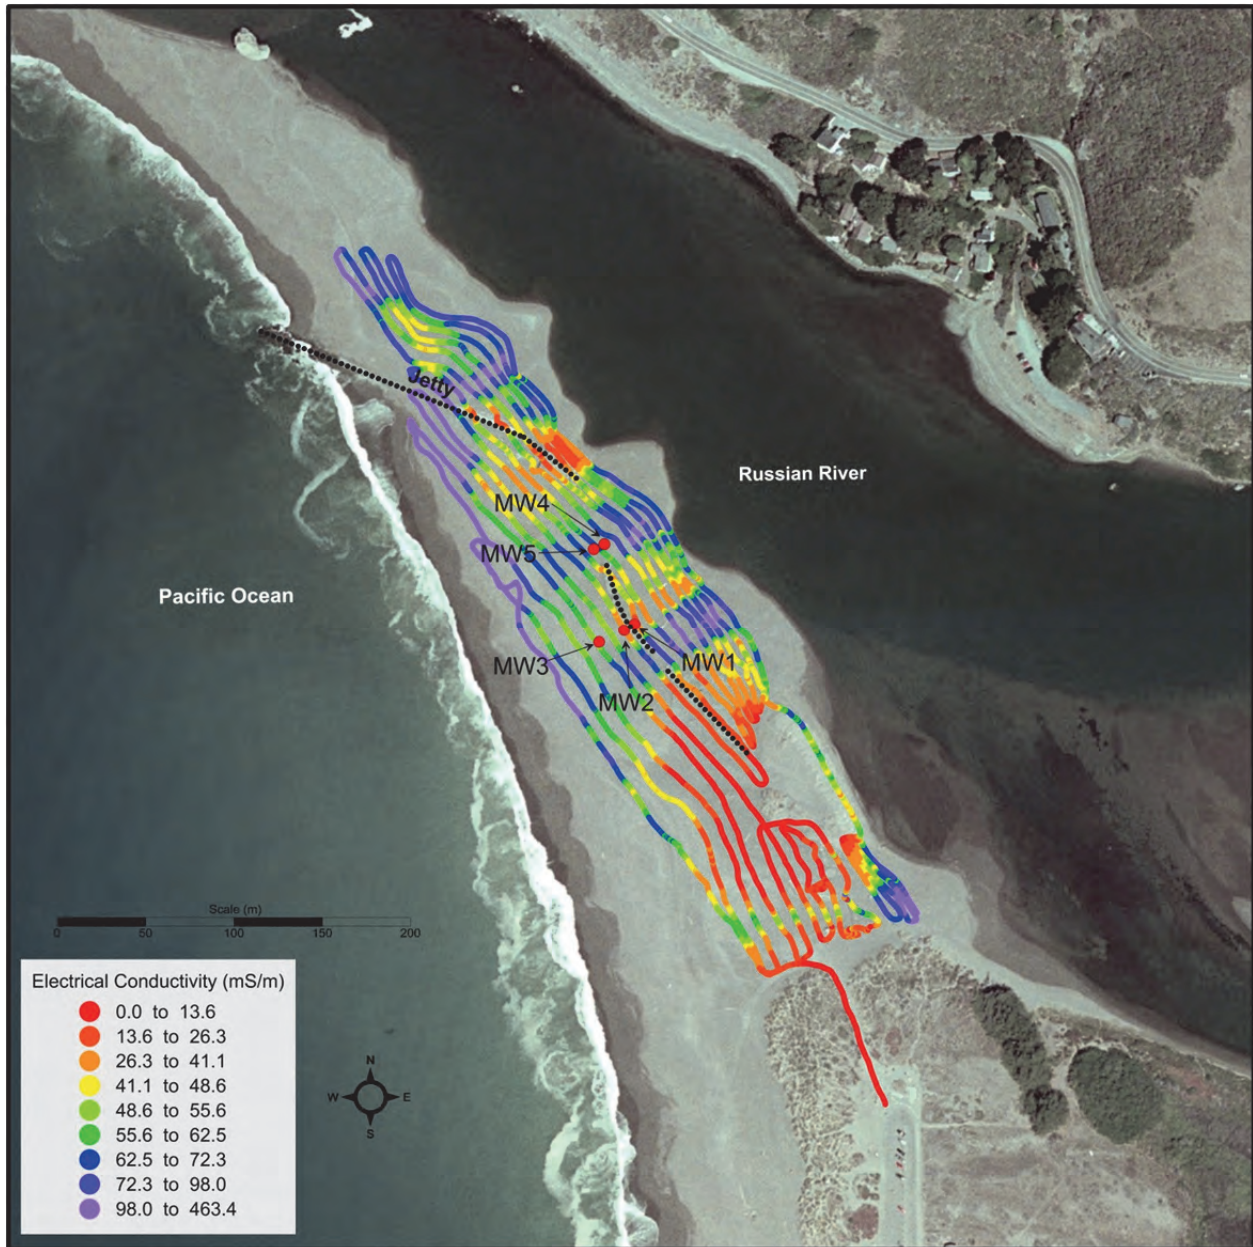
Figure 4. Plan view map showing the Jetty components, open river mouth zone, and electrical conductivity results from September 30<sup>th</sup>, 2014, survey. Lower salinity/dryer soils are represented by red to yellow colors and higher salinity/wetter soils by green to purple colors. Monitoring wells (red dots labeled by 'MW') installation locations were decided from the electrical conductivity results.
